# Field Hospitals – Lessons Learnt

STAFF SERGEANT J S TARRANT BA(H) DIPARCH ARB MINSTRE

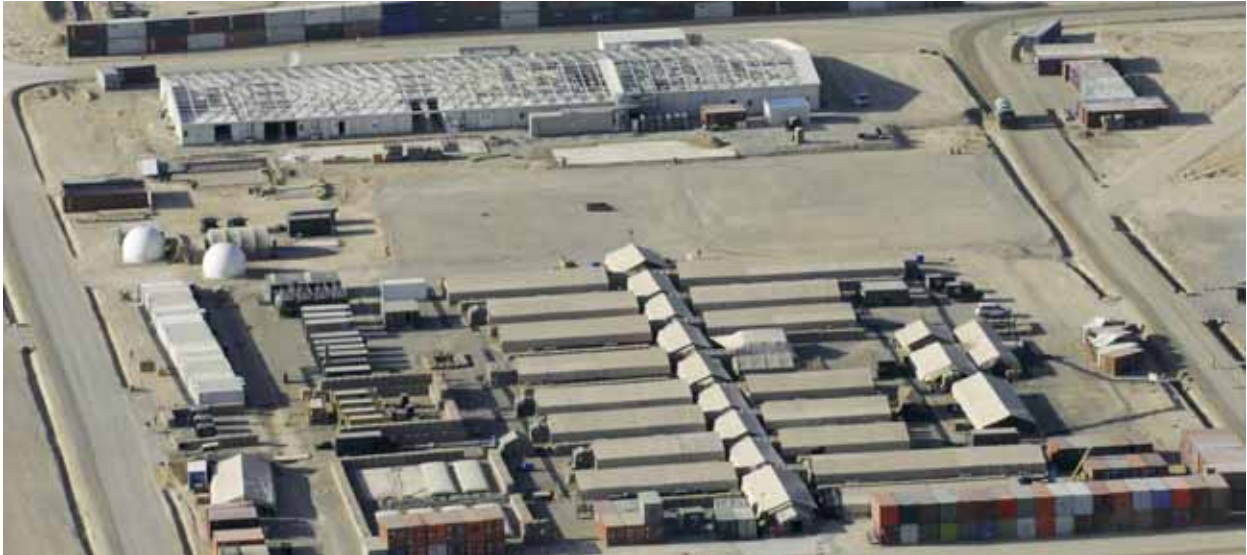
Figure 1. Aerial of T1 &amp; T2 hospitals in 2007

In June 2007, I arrived in BSN as Supervising Officer (SO) of the Role 2 Tier 2 Hospital (Figure 1). The Tier 1 hospital was in full use 50m away from the building site that was to be the new Tier 2 hospital with all its associated infrastructure and buildings. The building itself was about 40 per cent complete, a shell consisting of floors, walls, ceilings and roof structure with no sign of any services other than two huge air handling units and some of its associated ductwork. It was already nearly a year over-due and several million dollars over-budget and work had all but ground to a halt on a site that was being run by an ex-military ambulance driver who knew nothing about construction or running a construction site and with highly qualified tradesmen resigning every other day with the remaining ones achieving very little for every reason (many legitimate) under the sun. Five months later the building was 85 per cent complete and with a good momentum of work that saw it opened in February 2008.

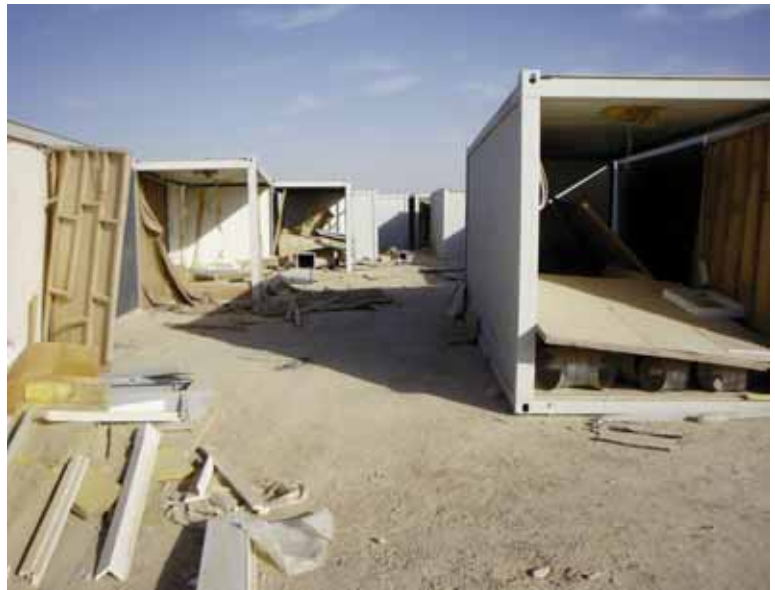
Figure 2. Basra Hospital having been relocated to a BSN compound.

The Basra Hospital was smaller than the BSN hospital but the construction was very similar – assembled steel-frame cabins clipped together with a large over-roof and fitted out as best they could with medical standard finishes and fittings with the intention that the whole building could be disassembled and relocated to anywhere in the world and then reassembled quickly for re-use. Eventually it was relocated to BSN where it arrived towards the end of 2010. However, by the time it arrived in its compound it was so damaged that to re-use any of it, the cabin would have had to be stripped back to floors, ceilings and a few undamaged wall panels and “refreshed” by a well-paid contractor.

Sadly, it was looted daily and none of the Basra Hospital was re-used as a medical facility (Figure 2).

So what went wrong? Certainly, temporary cabin units are a fairly flimsy form of construction and therefore they are prone to damage and make an easy target for looters at all stages of storage and transit but there is also the fact that during construction, once the cabins had been fitted together, the floors were covered in continuous vinyl sheets welded at the seams – a requirement under the HTM – which then had to be cut up when the hospital was disassembled. Likewise, water and foul drainage pipes, power and data cables all had to be disconnected, basically the cabins needed to be stripped right back to the shell just for transit. Sanitary fittings which were left in-situ became loose in transit due to the flimsiness of the panels and would require re-fitting if they are to be re-used.

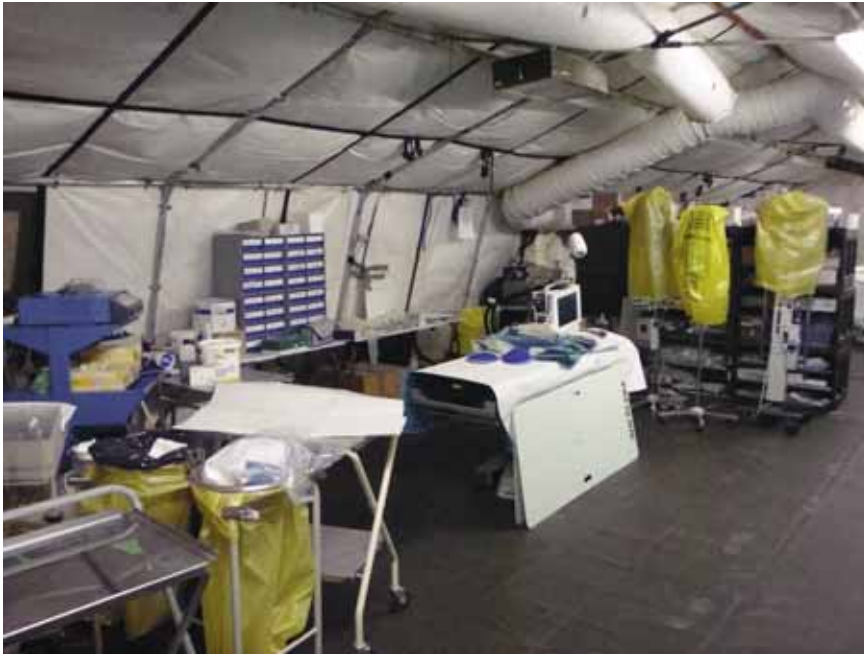
Figure 3. Tier 1 Operating Theatre.

We have tented hospitals (Figure 3) and they work well. A developed or hardened version of a tented hospital would be a containerized hospital based loosely on the mobile (and often expanding) containers used by NHS Trusts in the UK that are driven around to hospital sites and which often contain breast screening, blood collecting, etc. A series of these containers could be set up off a spine corridor in a similar layout to the T1 hospital in BSN. If containerized units are ever considered for use as a field hospital then tests should be undertaken to prove their suitability in various climates and for means of transport. Another type of construction would be a modular (for example a hesco protected) shelter with assembled elements that are similar to the hospital set-up found on a C17 (Figure 4).

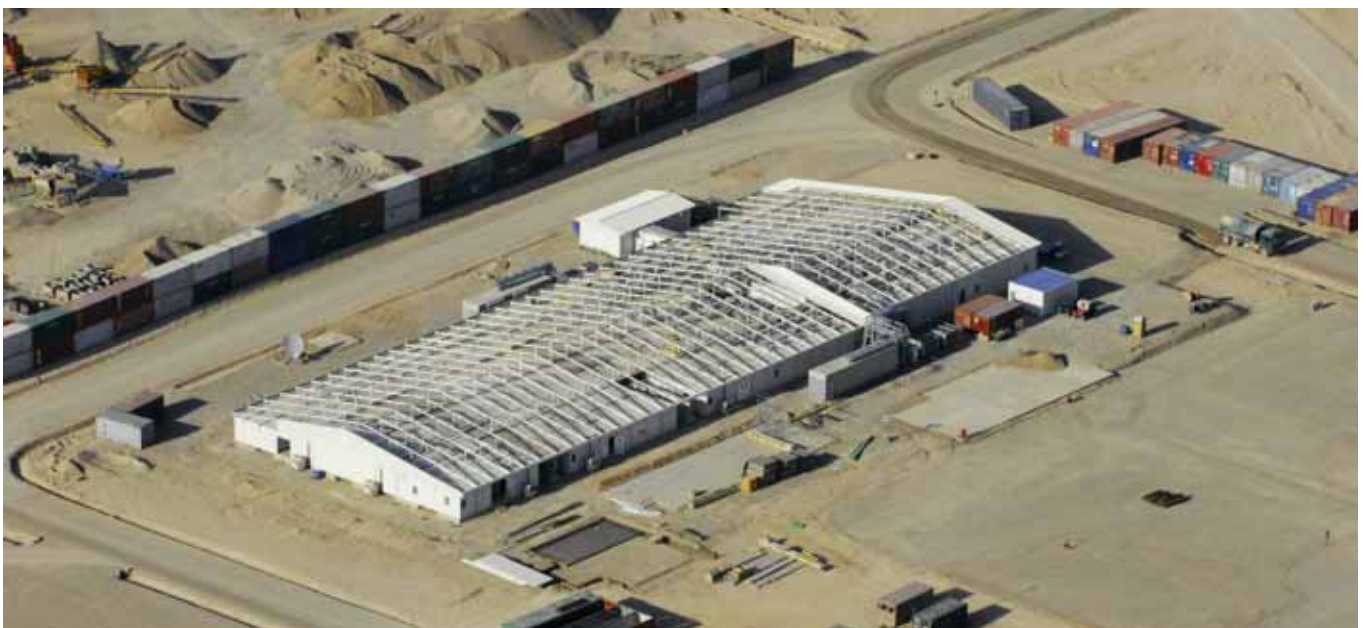
Figure 5. Concrete pads along the south side being prepared for services.

During the design process, it seems that there were several discussions about services supply: who was to supply it and in what form. This is evident from several places. In the contract there was a requirement that the contractor should design the plumbing system to take 7bar water pressure off the mains. When the cold water system was commissioned, there was barely 1bar of pressure in the mains and therefore could only be commissioned during the night when the pressure was slightly higher. Dedicated water storage tanks had to be added later to ensure a permanent pressurised water supply to the hospital. Another example was when the hospital was originally designed and contracted out, it was to receive power from a grid system as there were plans afoot at that time to install HV power in BSN. At the point when HV power was no longer considered viable, a design for five huge generators and the associated fuel storage and pipelines was quickly put together and the contract let. The water, generators and fuel tanks were all located on the south side of the hospital thereby blocking possibilities for future expansion – the other three sides were bound by roads, one of which was later closed off to build the covered ambulance drop-off area and the RHQ (Figure 5).

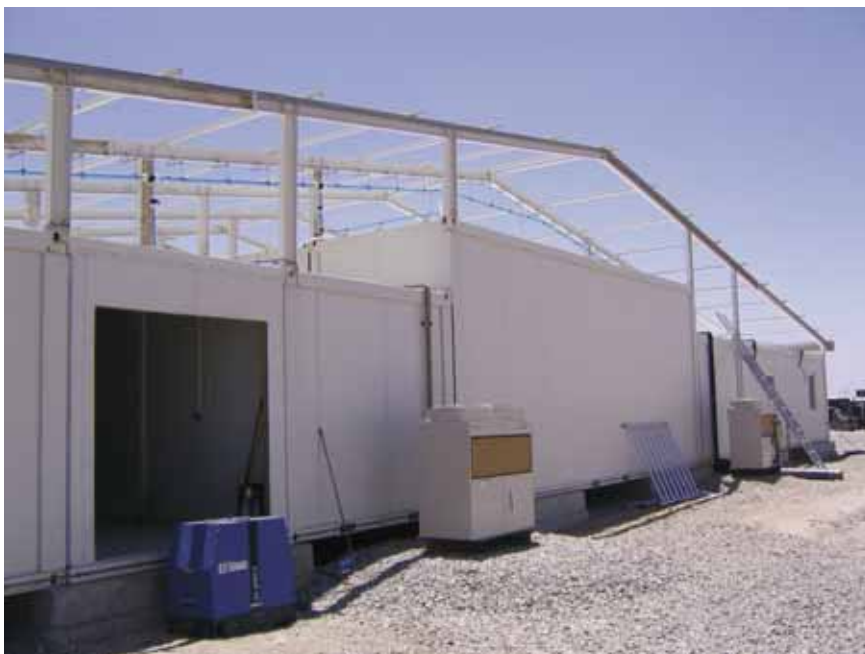
Figure 6. Steel frame cabins clipped together.

It is interesting that a steel frame structure (Figure 6) with unsealed insulated panel walls and ceiling and with floors only strong enough for office or sleeping accommodation was chosen for a hospital in a harsh desert environment with extreme temperature ranges. It is not known why this type of construction was chosen other than for the ease and ability to transport and assemble the individual units and the remote possibility that the hospital could be relocated every few years.

Steel frames expand and contract with temperature change creating all sorts of weaknesses within the building. It can only be put down to the extraordinary care of the tradesman that laid the vinyl floor that the floor has lasted as long as it has – it seems that when the floors started failing in 2010 it was due more to the increased weight of traffic than the movement of the steel frames.

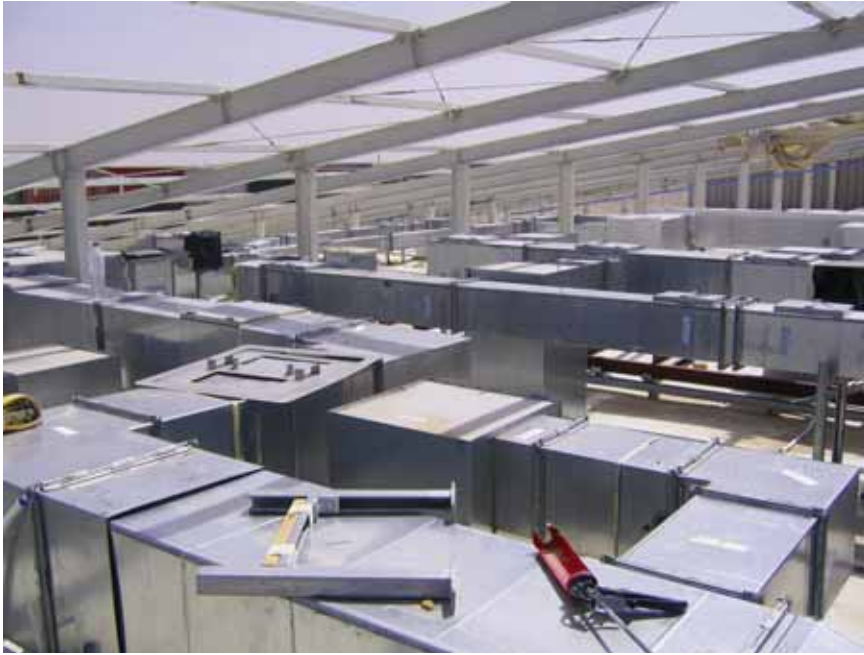
Figure 7. The roof void with services under construction.

The large over-roof structure is really the only sensible option for a field hospital due to the miles of large ductwork (Figure 7) required for the air handling system and numerous other services supply which all require regular access for cleaning and maintenance. At BSN some bright spark came up with the idea of pressurising the roof space in order to keep the dust out – this is an excellent idea and in future should be designed in from the start, however, the solution at BSN is lethal – the foul air expelled from the pressurised clean air system has been redirected into the roof space thereby contaminating the air (sometimes with tuberculosis) for maintenance workers. The HTM is quite clear about expelling foul air to the outside and sets minimum

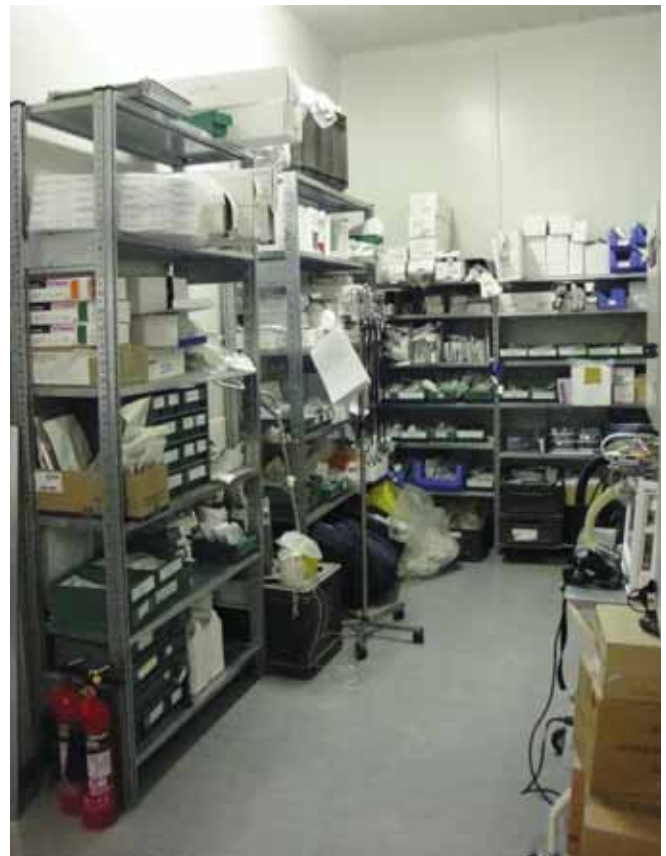
Figure 10. Corridor outside operating theatre crammed with storage blocking bed egress.

When a department runs out of space the first support rooms to disappear are the store rooms, also when a department increases in capability and capacity there is a disproportionate increase in the amount and size of medical equipment used. Inevitably shelves are brought in to line walls in the clinical areas so that consumables, electrical equipment, holders etc are stored on open shelves where they collect dust and eventually diseases. The practice of open storage is totally unacceptable and contravenes all DoH guidance and good practice. It is no wonder that in early 2010 the hospital in BSN had its first four super-bugs, the worst of which was found in dust around the open shelves in the operating theatre. At the time the hospital squadron were strongly resistant to improving the storage crises, it is not understood why (Figure 10).

popped up throughout the hospital leaving very few dedicated store rooms; entire bed-spaces in the wards were crammed with bulky equipment and the corridors were lined with so many shelves that beds could not be taken out of the operating theatre through the normal route.
